#### 2004 GEODETIC CONTROL PROJECT

# MONUMENT RECORD

### STATE OF INDIANA ~ COUNTY OF MONROE

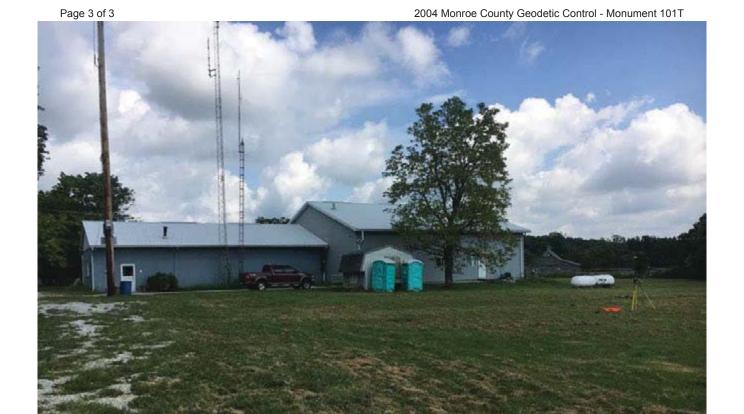
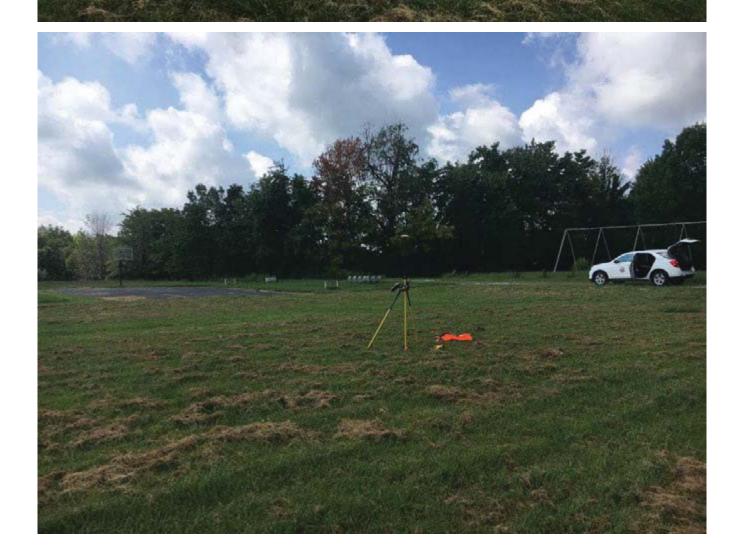
Corner I.D. # 101T

/31/2016, Rachel Savich Oser, Fbk. 48, pg. 7 /24/2018, Cassidy Raley, Fbk. 52, pg. 22 Ionument recovered in good condition	tic Control Survey.)
Rockport Road  Indian Creek Twp. Fire Station Bldg.	18" Catalpa
Gravel Lane  Grave	oall N.T.S.
	Aluminum Monument

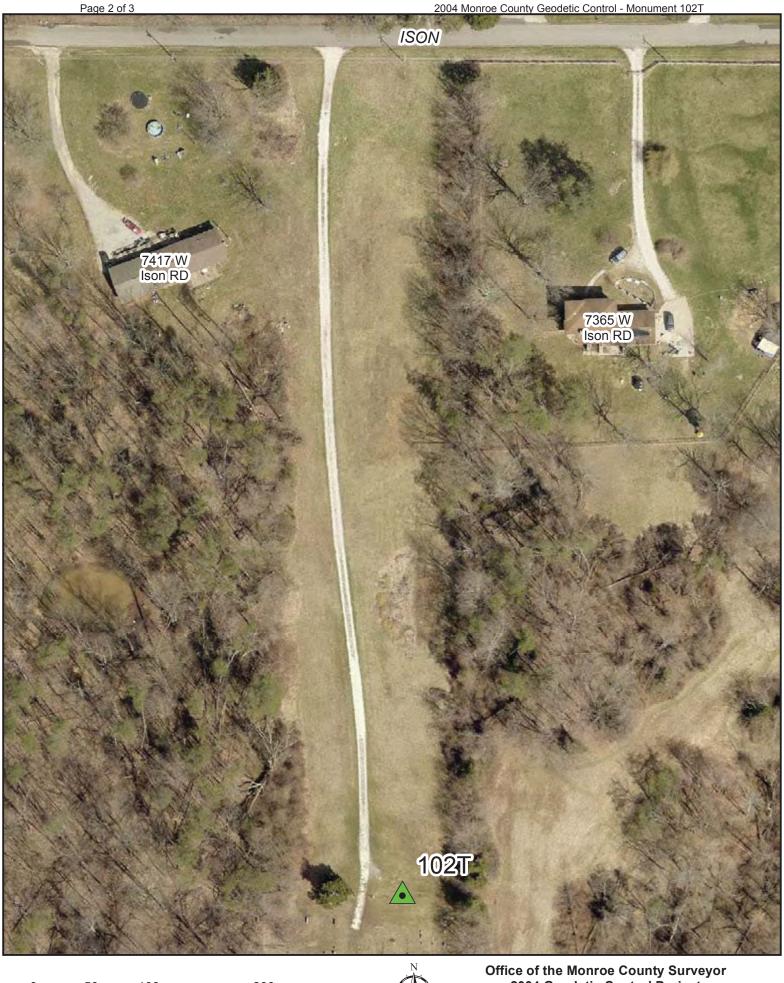
Corner I.D. # 102T

D		-
	Recovery Tie Drav	wing	
			-
West Isom	Road		
8/31/2016, Rachel Savich Oser, Fbk. 48, pg. 6 7/24/2018, Cassidy Raley, Fbk. 52, pg. 22 Monument recovered in fair condition Aluminum cap is not properly seated on rod, rod appears solid Eastern sky is partially obstructed by treeline		+	
Wood Post w/-	5.7	N N.T.S.	
HARMON	Aluminum Mor	ument

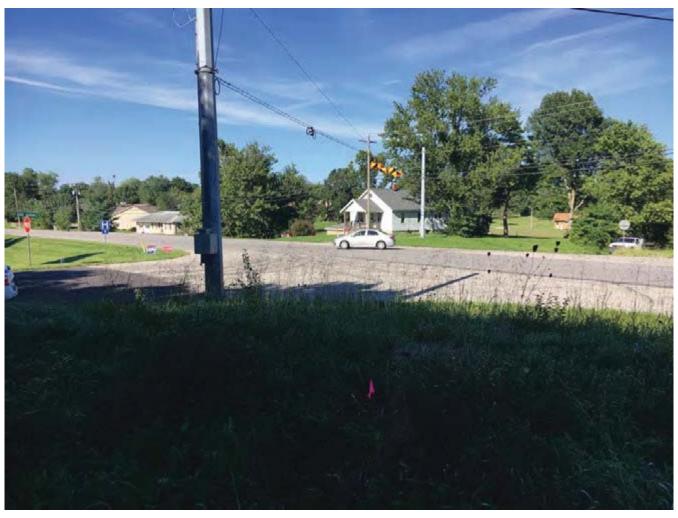
Corner I.D. # 106T

8/23/2016, Rachel Savich Oser, Fbk. 48, pg. 47/25/2018, Cassidy Raley, Fbk. 52, pg. 22 Wonument recovered flush with ground, apport the whole thing is crooked	+	been disturbed. Cap is still connected to rod,	•
	446	Q Traffic Signal Pole (S. Bolt)	4
	oć vi	Fire Hydrant (N. Bolt)	N N.T.S.
		- T-	Aluminum Monument at Corner = 0

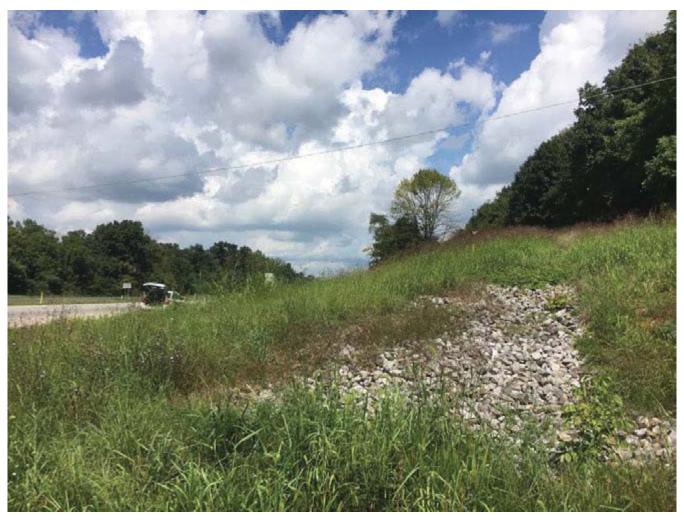
Corner I.D. # 111T

8/22/2016, Rachel Savich Oser, Fbk. 48, pg. 3  Monument recovered. Cap was not attached to the rod, which was solid in the grou Placed cap upside down on rod and replaced sod. 7/24/2018, Cassidy Raley, Fbk. 52, pg. 22	
Stinesvill Elementary School playgra	und
6"Tree Quig 6-11.6' Parking Lot	
Tobor Hill Road Edge of Conc.	- <u>_</u>
	N N.T.S.
'	Aluminum Monument at Comer = 9

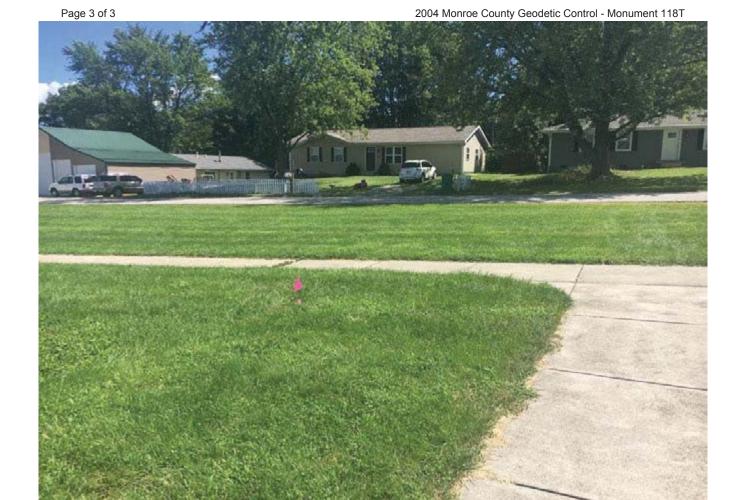
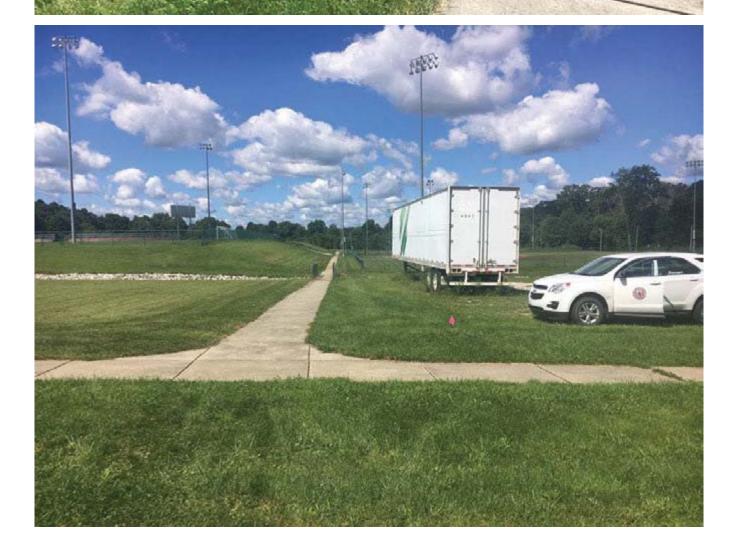
Corner I.D. # 118T

inis monument is	not d PLSS corner.	it was set as part of a	Geodetic Control Survey.)
	p was not attached to the rod, de and solid in the ground. In rod and buried.	ecovery Tie Drawing	
Baseball Field	Gravel Parking area  7.5	Sycomore Dr.	DAR Dr.  N N.T.S.
Soccer Field			Aluminum Monument at Corner = •
